Initial post by Chuck on March 22, 2009 at 1:53pm

I have a crack that appeared about four years ago about 24" up on the rudder support. At the time I ground in about 1/2" and feathered up and down. Wrapped fiberglass in layers about 8" on either side of the crack. That seemed to hold it for a while but over time the crack slowly reappeared. I nor the marina knows if there is a metal plate in the support or if there is another attachment method. I don't care about the crack I just don't need to have total failure of the support. Boat is stationed in the North Channel in the summer. In the winter she is Stored in Charlevoix, Michigan. Any ideas? She is a 1979 Mariner 36. Thanks

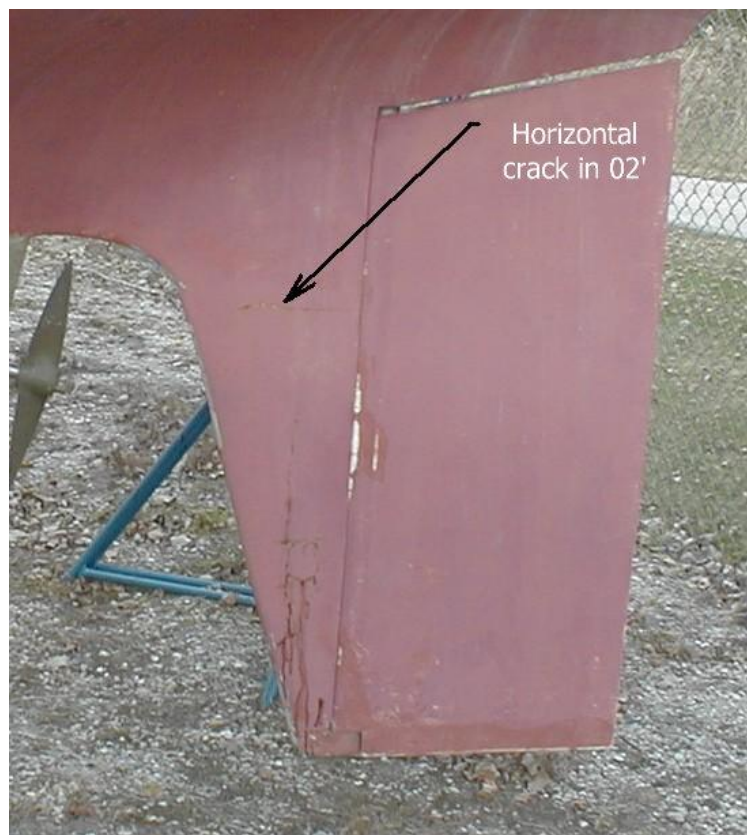
The threaded rod in my rudder skeg that holds the [rudder shoe](#) to the skeg corroded and the original skeg shoe is somewhere on the Great River Loop. I have had a crack since I bought it Here is a picture taken in 2002.

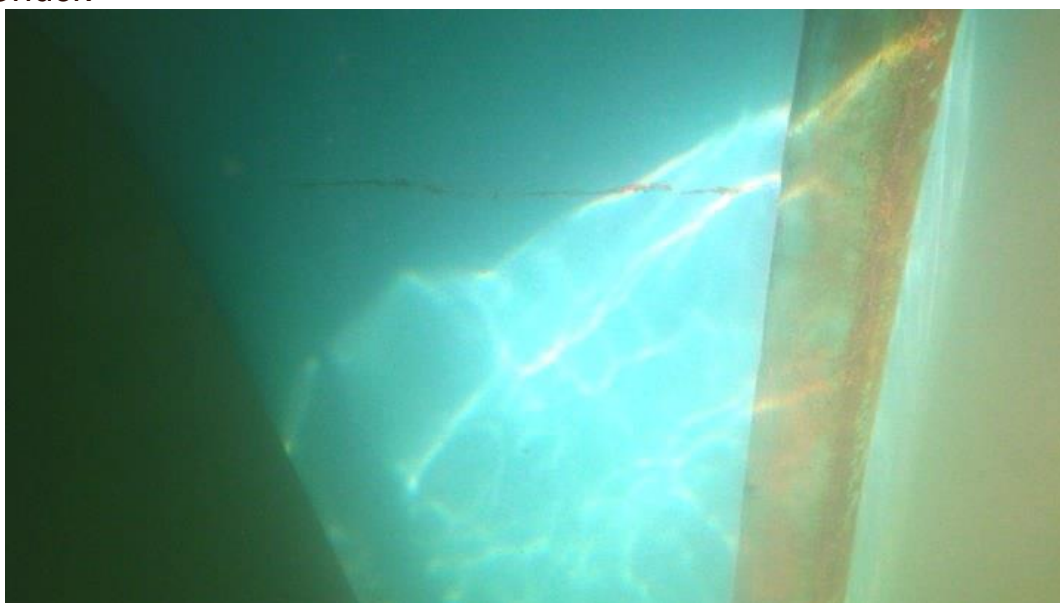
How did your repair work out. While cleaning the hull in the water we discovered the crack. It was not there two years ago when the bottom was painted. I did hit a log while motoring but I thought it hit the keel, who knows. I will keep an eye on it and see what happens. Any advice would be appreciated.

Above is the underwater picture of the skeg crack. Looks bad but what I've read I should be OK until I pull the boat out next year for new bottom paint. Is the nut visible at the bottom of the skeg? I can have the bottom cleaner check the skeg attachment next time he cleans the bottom. I don't want it to drop off as what happened to Markus's boat. I guess the crack was caused when I hit a log while motoring home one night. Thanks again for your response. Contact me if you are in the Bay area we can go out for a sail.

The crack is only on one side. I think the log we hit first contacted the keel and then hit the port side of the skeg. Can you tell me if the nut is under the skeg shoe? I was thinking of having the diver who cleans the bottom of the boat tighten the nut while its still in the water. I can't tell from the forum's discussion from Bill Ferguson and Markus if I have to get at the threaded rod from inside the hull or if I can tighten it up from under the skeg shoe. I was going to wait until I pull the boat to repaint the bottom in Oct. 2014 and do the fiberglass repair but now I'm getting concerned about the water causing corrosion damage to the threaded rod. Any comments would be appreciated.

I am assuming the crack is on both sides. If so that is the flex point. The bottom pivot needs to be removed as I remember but the nut is readily accessible and a turn or two would keep everything tight until the fiberglass is repaired have your man grab the skeg at the bottom and check for flex. A little is okay. A lot is not. You do want to fix the fiberglass so that the water does not seep inside the bolt race over time. Looks just like mine a couple of years ago. Good Luck and the offer is returned if you are ever in the North Channel around St. Joseph Island
